FOX FLAT RATE HOME INSPECTIONS

YOUR HOME INSPECTION 7-6

1120 Edgar St
Greenville, TX 75401

PROPERTY INSPECTION REPORT FORM

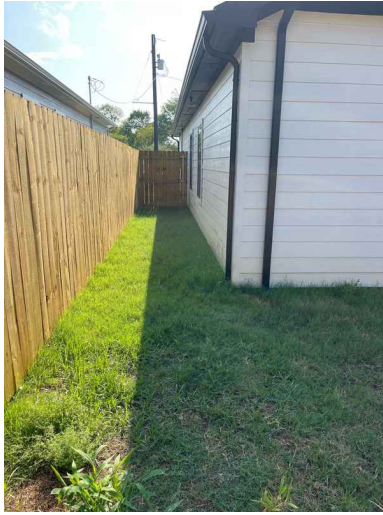
1: Standing Water Observed

Signs of Standing water observed, which could indicate poor drainage and/or grading. Correction will be needed if water stands within 10ft of the foundation for more than 24 hours. Recommend having a landscaper correct.

[Here is a resource](#) on dealing with standing water in your yard.

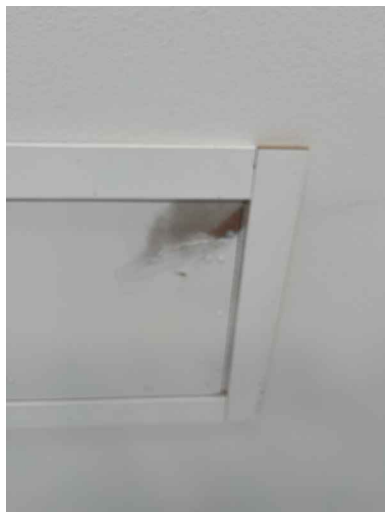
2: Attic Door Damaged

Attic door damaged - paint missing

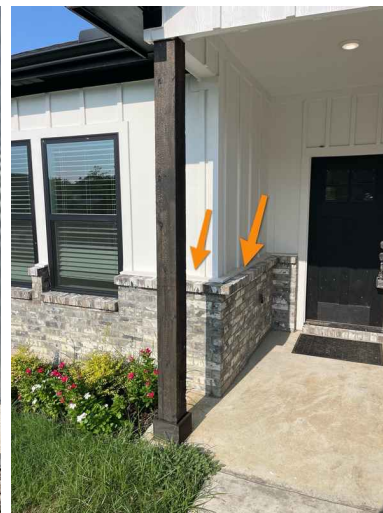
1: Sealant Recommended

Missing or damaged sealant in one or more locations. Recommend sealing to prevent water intrusion and pest from nesting inside the walls and attic.

Pictures may not be of every defect but a sample of defects. All defects that resemble the above and areas in the reference should be repaired.

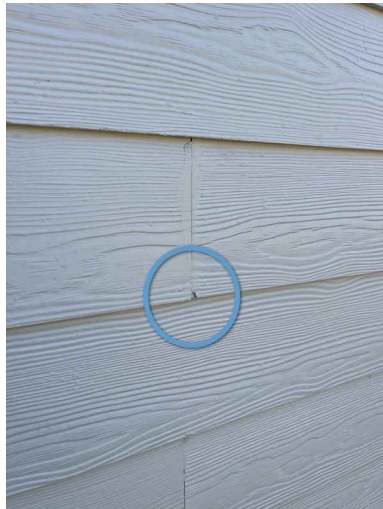
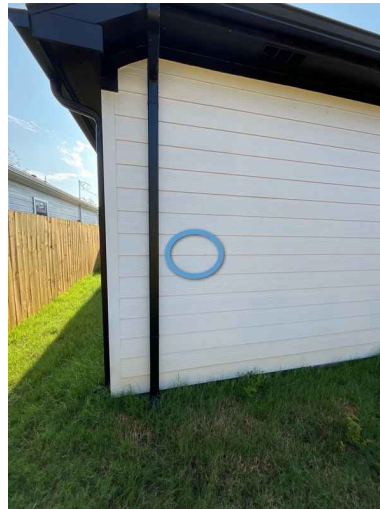
3: Siding Damaged

Siding/Trim Damaged. *Repair or replacement recommended as needed.*

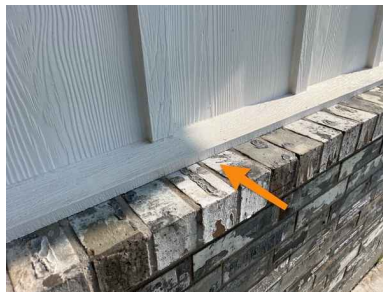
4: Cladding Transition Missing Flashing

Missing flashing between the cladding transition and the brick veneer. Flashing should be installed at transitions. This may lead to water penetration in these areas over time.

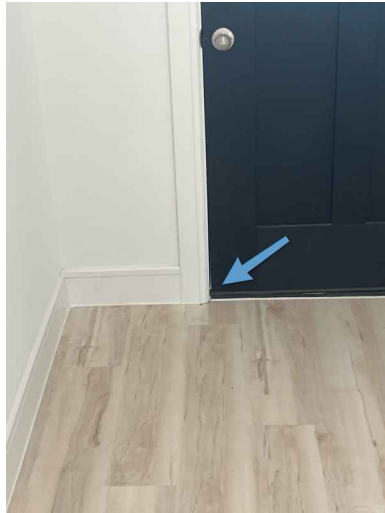
1: Weatherstripping Damaged or Missing
[Information/Maintenance Items/Minor Concerns](#)

One or more exterior doors are missing or have damaged weatherstripping. This can result in significant energy loss and moisture intrusion. Recommend installation of standard weatherstripping.

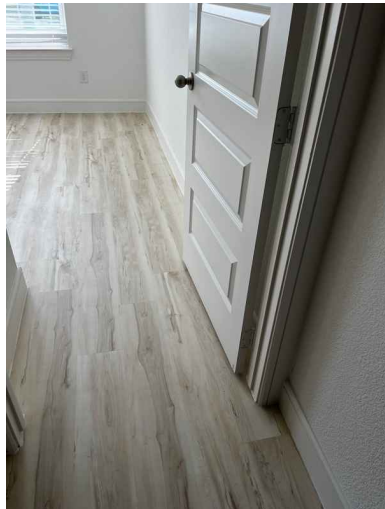
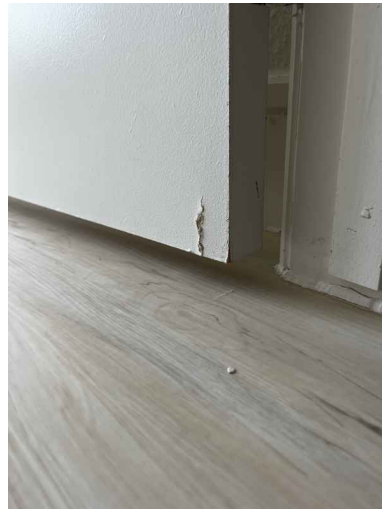
2: Damaged

Door is damaged

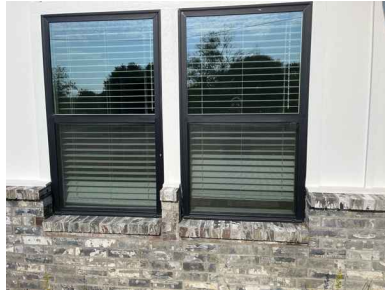
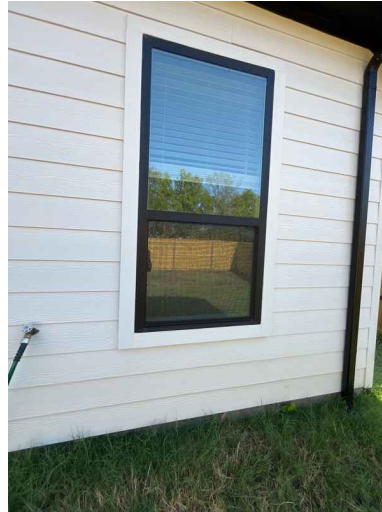
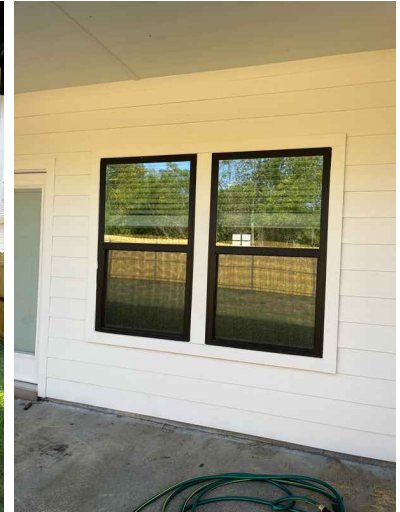
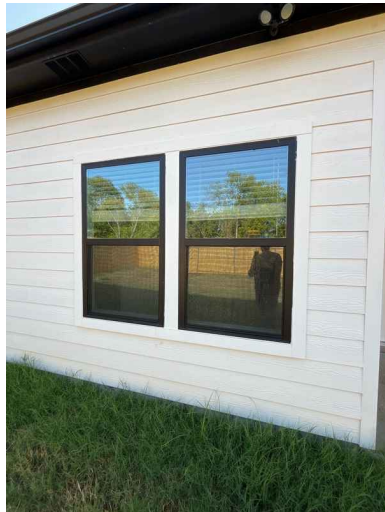
Sealant needed on exterior windows to prevent water intrusion.

Pictures may not be of every defect, but a sample of defects. Consistent occurrences should be repaired.

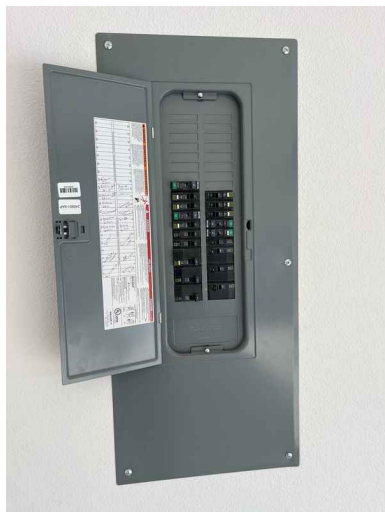
Service Amp: 200 -

The available max amperage available for this property. Anything under 200 may be insufficient for today's needs.

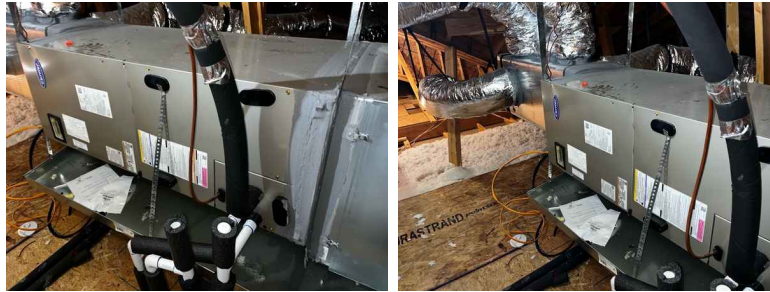
Furnace/Heat Unit Condition:

This is to show you the condition of the heating unit on the day of the inspection.

Brand: Carrier

Estimated Unit Age: 24

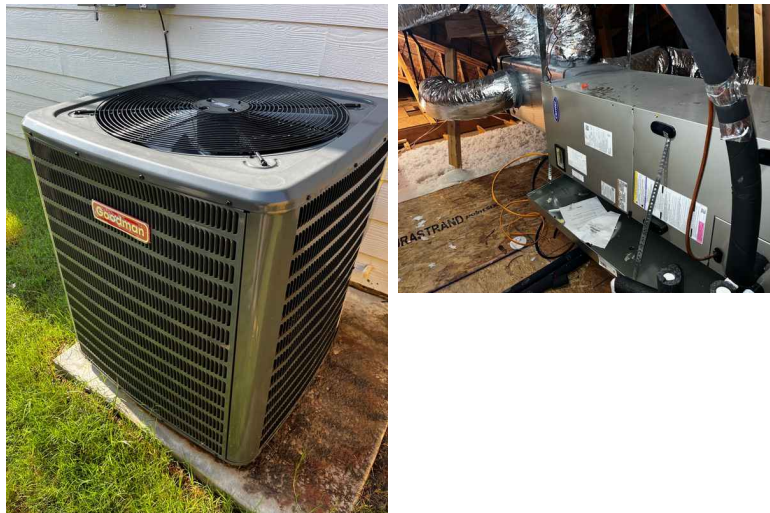
Manufacturer of the furnace (indoor unit) is different than the exterior manufacturer (condenser). more information about the replacement is needed. (Issue that caused replacement, any warranties available)

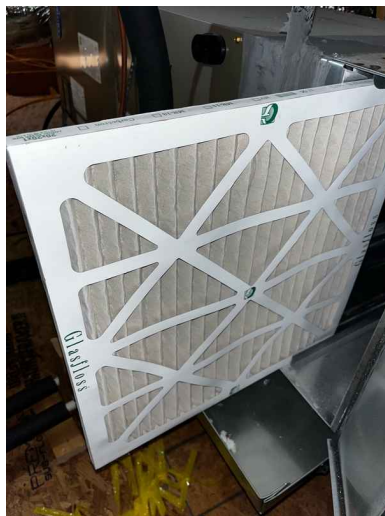
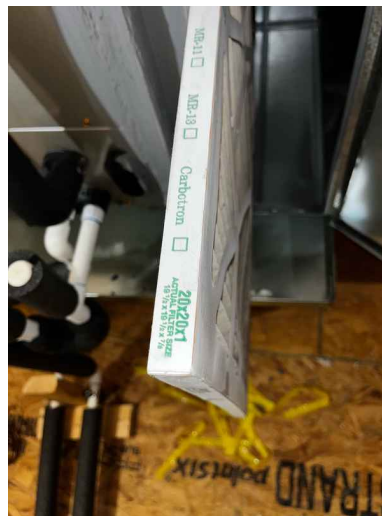
Filter Condition:

Filter Location: At Unit

Recommend changing filters every 30-45 days

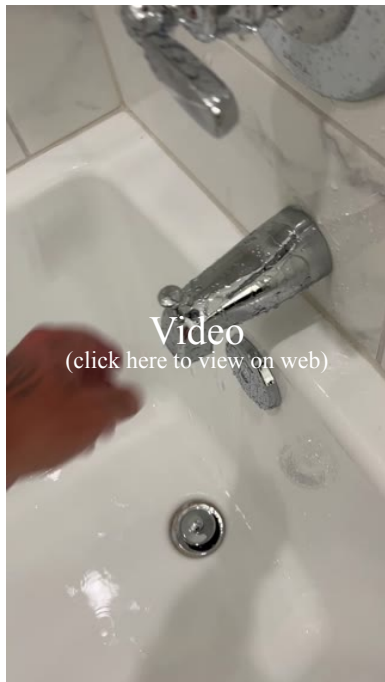
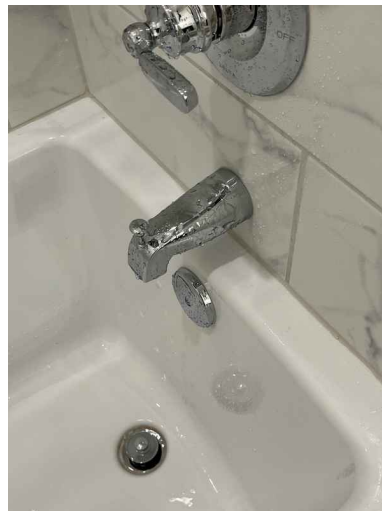
2: Loose Fixture

Fixture needs to be tightened.

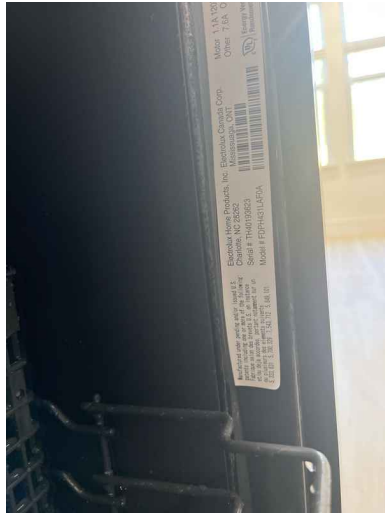
Manufacturer Information:

Tested:

Dishwasher was tested for operation and leaks. None present at the time of the inspection.

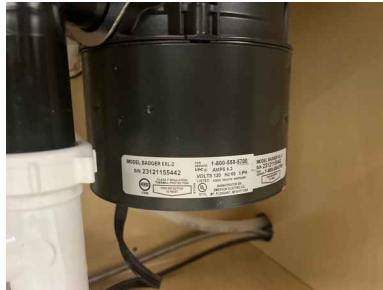
Manufacturer Information:

Tested:

Disposal was tested and working

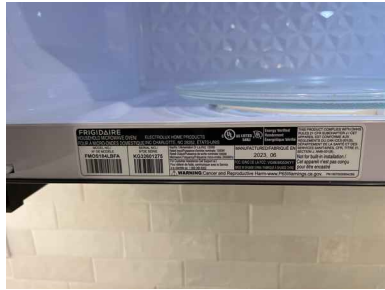
Tested:
Microwave tested and operational
